**Safety Review of Carlton Street Bus Route**

# Appendix A – Road Safety Audit Report

## Carlton Street Bus Route

Prepared for Auckland Transport  
by Beca Limited

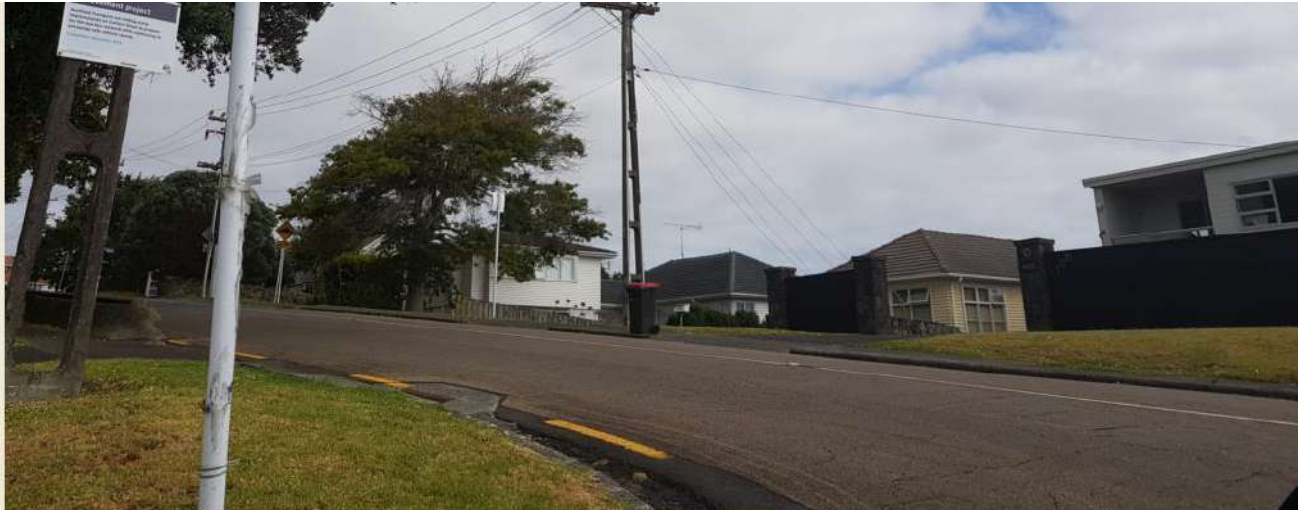
- The principles set out in the Austroads guide for 'Safe Intersection Sight Distance'<sup>1</sup> (SISD) were used to estimate the required sight distance. SISD reflects the intervisibility distance between drivers on Carlton Street and a driver waiting on Frederick Street for an opportunity to enter Carlton Street. The SISD required towards Carlton Street for traffic exiting Frederick Street was calculated to be 65m and on site this was observed to be approximately 60m (Note that these on-site assessments are estimates only as no topography survey data was available to confirm the geometry of the road). This indicates that currently the sight distance towards Carlton Street for vehicles exiting Frederick Street has minor deficiencies due to the geometric layout.

Figure 1: Limited sight distance on left for side for traffic exiting Frederick Street towards Carlton Street

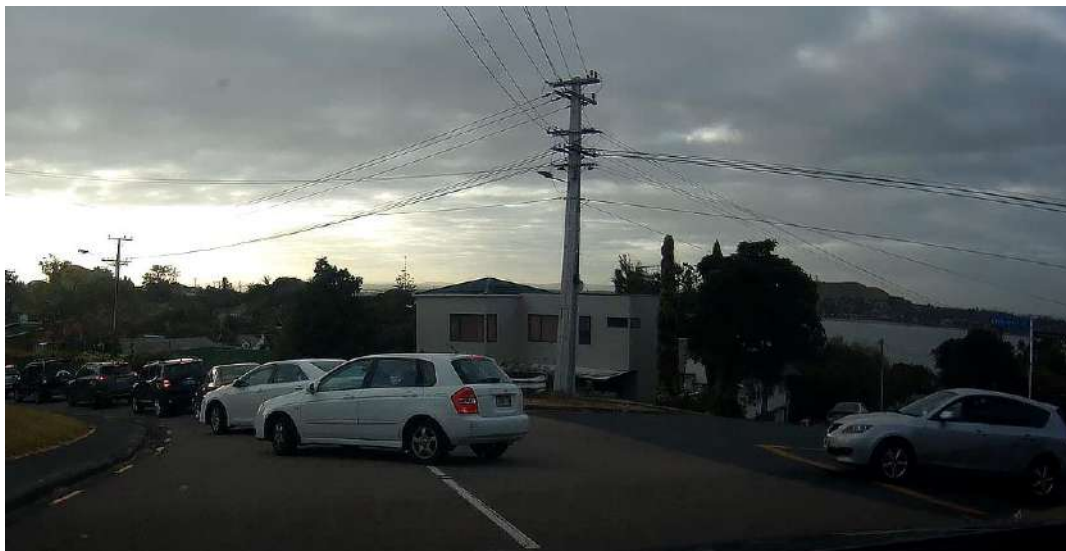
- During the AM period, it was observed that the vehicle queue in the eastbound direction along Carlton Street extends past this intersection and there was extensive queuing along Frederick Street. It was difficult for the traffic wanting to turn right out of Frederick Street to find a gap and excessive waiting times were observed. These delays result in frustration, with some drivers observed to be undertaking risky merging movements such as forcing their way into small gaps and partially straddling over the westbound lane. The westbound drivers may not anticipate a partially straddled vehicle increasing the risk of collision. However, this existing safety risk is unlikely to be exacerbated due to the running of the buses along this corridor.

Figure 2: AM Peak queues along Carlton Street towards Queenstown Road at the Frederick Street intersection.

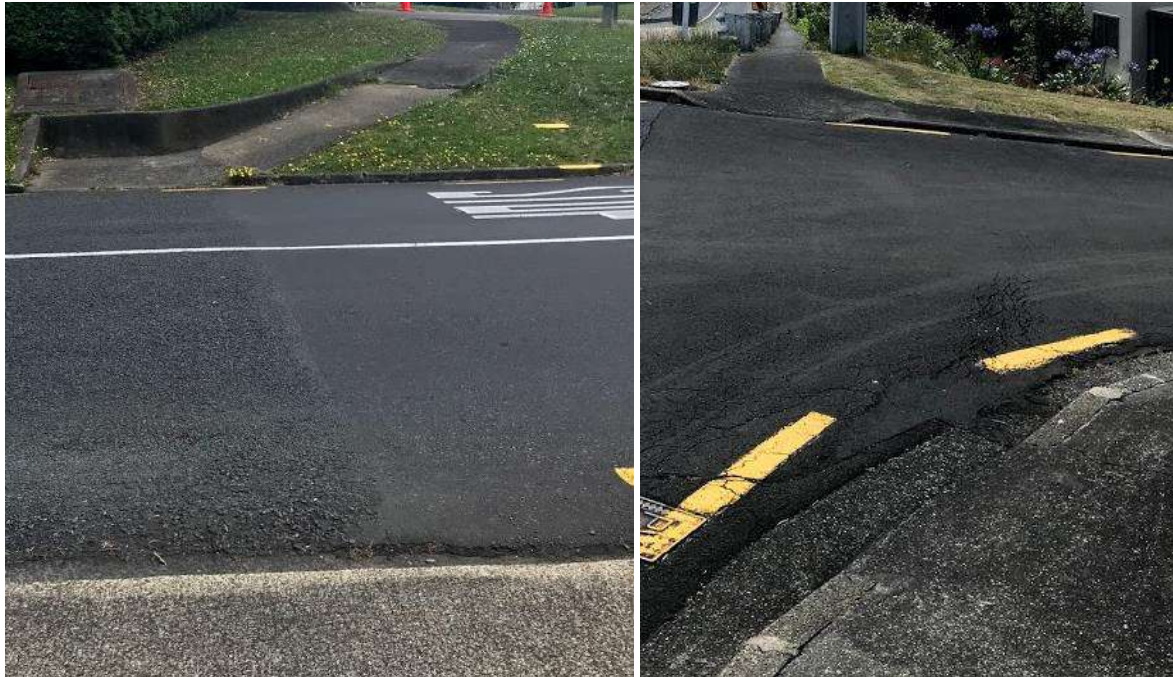
At present, there are no median refuge islands or other crossing facilities across Frederick Street and Lilac Grove. The current pram ramps are substandard, narrow and not orientated correctly. The surface conditions are uneven. There are no tactile ground surface indicators (TGSIs) for visually impaired footpath users. The gradient of the footpath and the pram ramp towards Carlton Street may not be suitable for mobility scooter or wheelchair users. If pedestrians with mobility aids, wheelchairs or walking frames were to access the bus stops from Queenstown Road, these users may not be able to access the bus stops at this intersection independently due to the poor crossing facilities across Frederick Street. Note that the footpath widths approaching these pram crossings are also narrow due to the roadside safety barrier and concrete barrier further limiting the access to these bus stops for mobility scooters, wheelchairs and prams (raised in **Section 2.4**).

Figure 3: Pram crossing facilities in poor condition across Frederick Street and Lilac Grove.

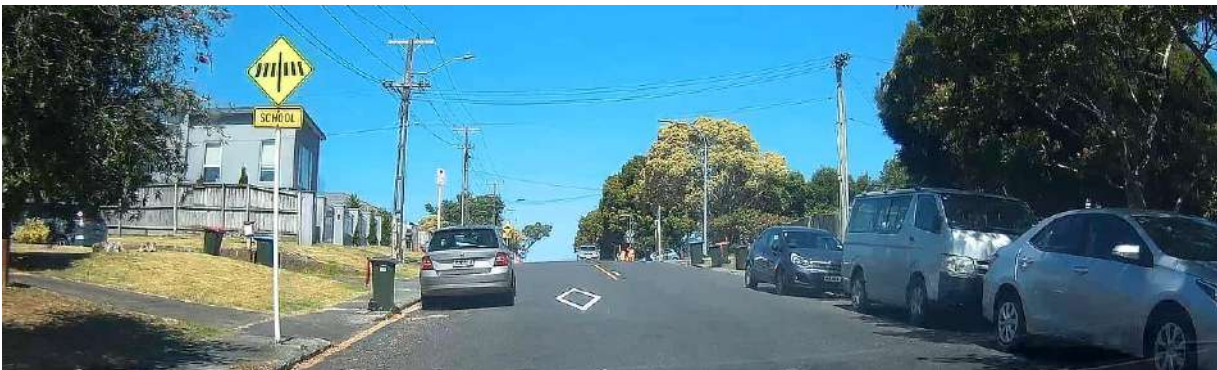
The proposed zebra crossing in front of the school access is located on the crest of the hill. Which means drivers approaching this crossing from Hillsborough Road would have limited visibility to the zebra crossing markings due to the road geometry. The approach speeds for this zebra crossing is estimated to be 30km/h-35km/h due to the raised table. Based on the principles set out in the Austroads guide for ‘Approach Sight Distance’ (ASD), the required ASD to the zebra crossing is calculated at 31m. At this location, the drivers have limited forward visibility to the zebra crossing ahead due to the road geometry. However, there are warning measures provided such as the advanced warning diamond pavement marking and the PW-30 to inform drivers of the zebra crossing ahead. During the school start and end periods, the kea crossing is in operation and there is a ‘clear way’ in operation. These further enhance the message to approaching drivers of the crossing facility ahead. Therefore, the likelihood of a crash occurring at this location is low. However, should a crash occur the severity of the crash is low given the approach speed to this crossing is low due to uphill gradient and the speed table approaching the crossing. On site it was noted that the belisha discs were not provided at this crossing and these signs provide additional warning of the pedestrian crossing ahead for approaching drivers. This issue was also similar in the westbound direction approaching the zebra crossing.

Figure 4: Eastbound view at approximately 50m to the Zebra Crossing

- Install belisha discs at the zebra crossing on both approaches on along Carlton Street and recommend gating these signs.
- Regular enforcement to be undertaken so that residents or school users don't park during the 'clear way operations'

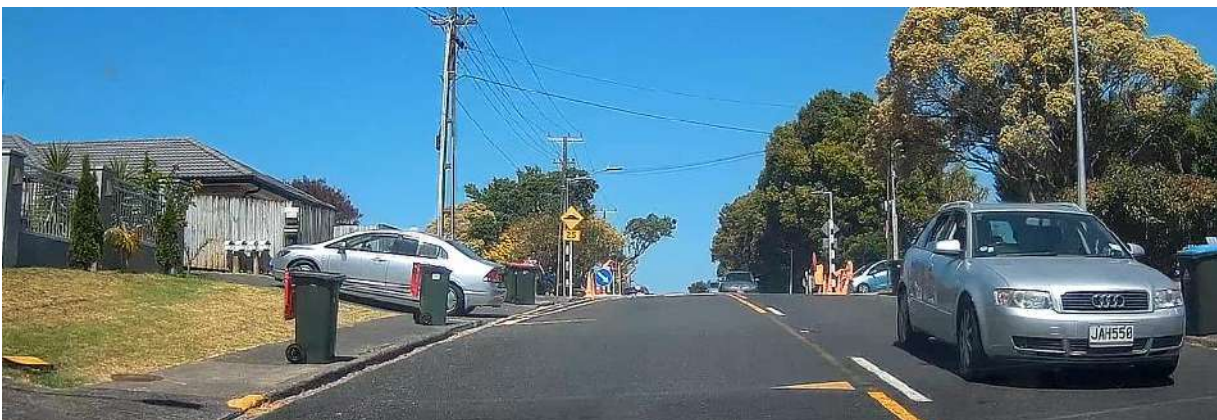
Figure 5: Eastbound view at approximately 30m to the Zebra Crossing

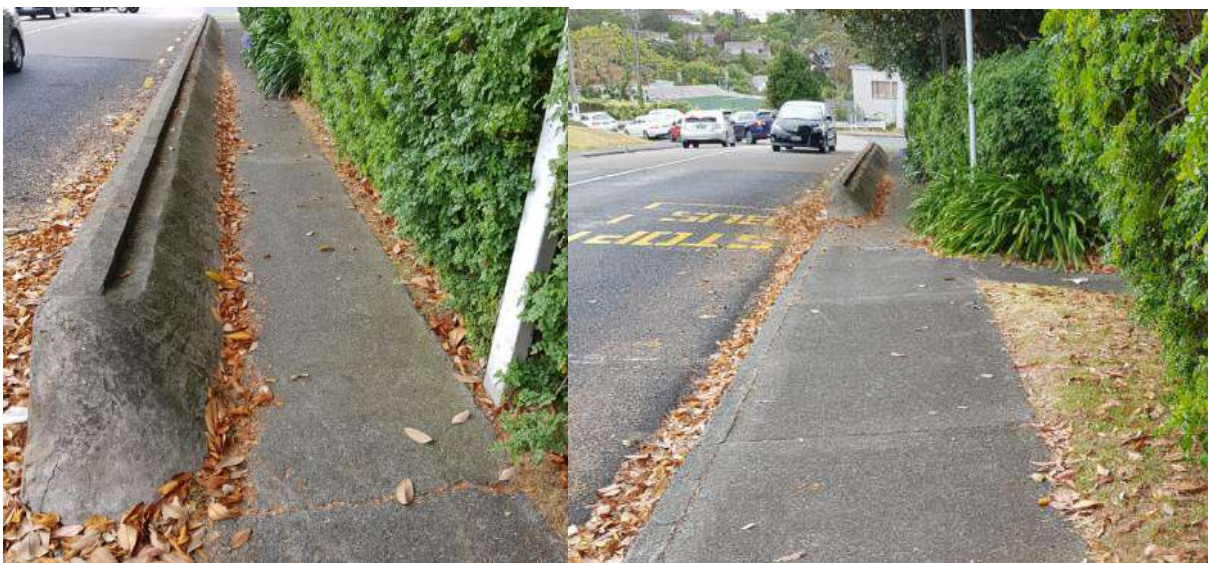
There is a section of the footpath where the usable width is reduced to about 500mm due to the vegetation and the concrete wall near the corner of the Frederick Street/Carlton Street intersection (**Figure 6**). SAT was unable to ascertain the purpose of this concrete barrier other than likely reasoning being to deter/stop a vehicle mounting the footpath. SAT believes this concrete wall poses a hazard to road users as it is not delineated appropriately and reduce the usable width available for footpath users. This concrete wall is about 500mm wide and removal of this could provide wider footpath at this location. Given this location is where the first westbound bus stop is located, wider footpath is needed at this location to allow for safe access to all bus stop users.

Figure 6: Concrete wall and vegetation reducing the usable width of the footpath near the westbound bus stop near Frederick Street.

- Widening the footpath along the corridor so that a minimum of 1.8m wide continuous footpath is provided along corridor. SAT believes that this may be challenging given the proximity to property boundaries and other onsite constraints. One possible option could be to widen the footpath towards the roadside and remove on street parking. However, this may affect the residents who are currently utilising these parking spaces. Therefore, it is recommended that AT investigate options of localised widening where possible, predominantly near bus stops and locations where the footpath widths are currently very narrow.

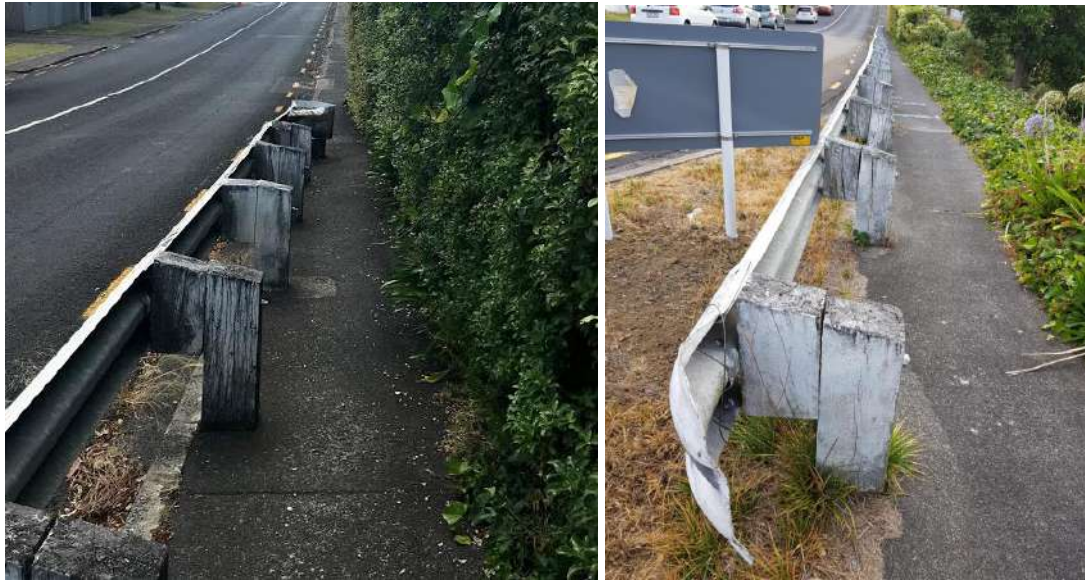
There is a section of the footpath where the usable width is reduced to about 500mm due to roadside barrier located along Frederick Street around the corner of the Frederick Street/Carlton Street intersection. This barrier appears have been to be provided to delineate the curve and to protect a vehicle losing control falling off the drop off at the apex of the curve. On site, the SAT noted that this barrier appears to be substandard. Further to that, this barrier reduces the useable width of the footpath for the users, especially for mobility scooters, wheelchairs or pram users.

Figure 7: Existing barrier reducing the usable width of the footpath

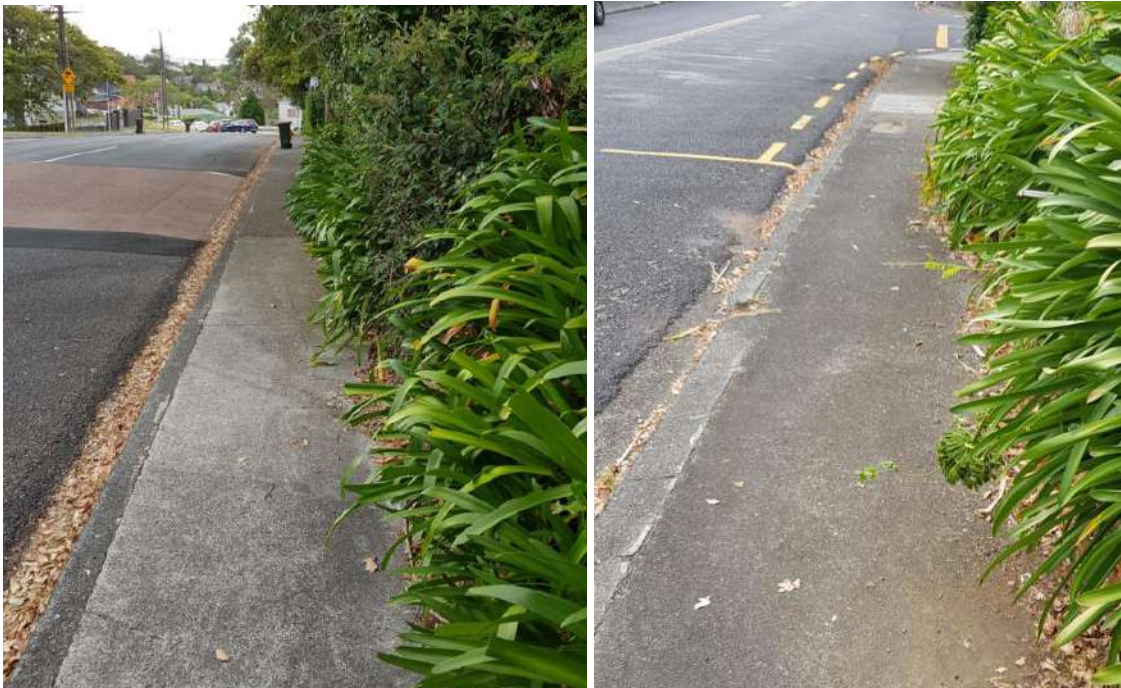
Further to that, there were a few sections along the westbound footpath that vegetation was reducing the width of the footpaths to well below 1m (**Figure 8**).

Figure 8: Overgrown vegetation reducing the usable width of the footpath.

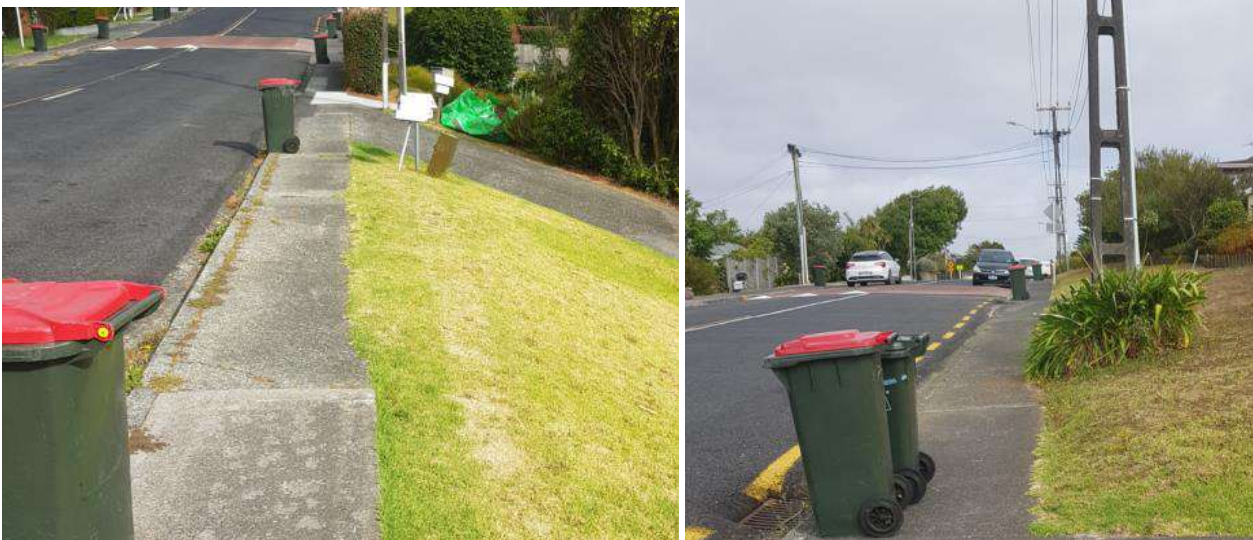
The footpath width along the eastbound carriageway was narrow with most sections being less than 1.5m with some sections being below 1m. Given this route is used by school children to walk to school and the walking school bus, some sections of the existing footpath widths are substandard. There are also some short sections where properties adjacent to footpaths have drop offs creating minor fall hazard to footpaths users. Some sections of this narrow sections of the footpath may not be suitable for users on a mobility scooter or wheelchair users. Therefore, there is an existing safety risk for all footpath users along this side due to narrow widths and uneven surfaces.

Figure 9: Examples of narrow footpath sections along the eastbound direction on Carlton Street.

- Widening the footpath along the corridor so that a minimum of 1.8m wide continuous footpath is provided along corridor. SAT believes that this may be challenging given the proximity to property boundaries and other onsite constraints. One possible option could be to widen the footpath towards the roadside and remove on road parking. However, this may affect the residents who are currently utilising these parking spaces. Therefore, recommends AT to investigate options of localised widening where possible, predominantly near bus stops and locations where the footpath widths are currently very narrow.

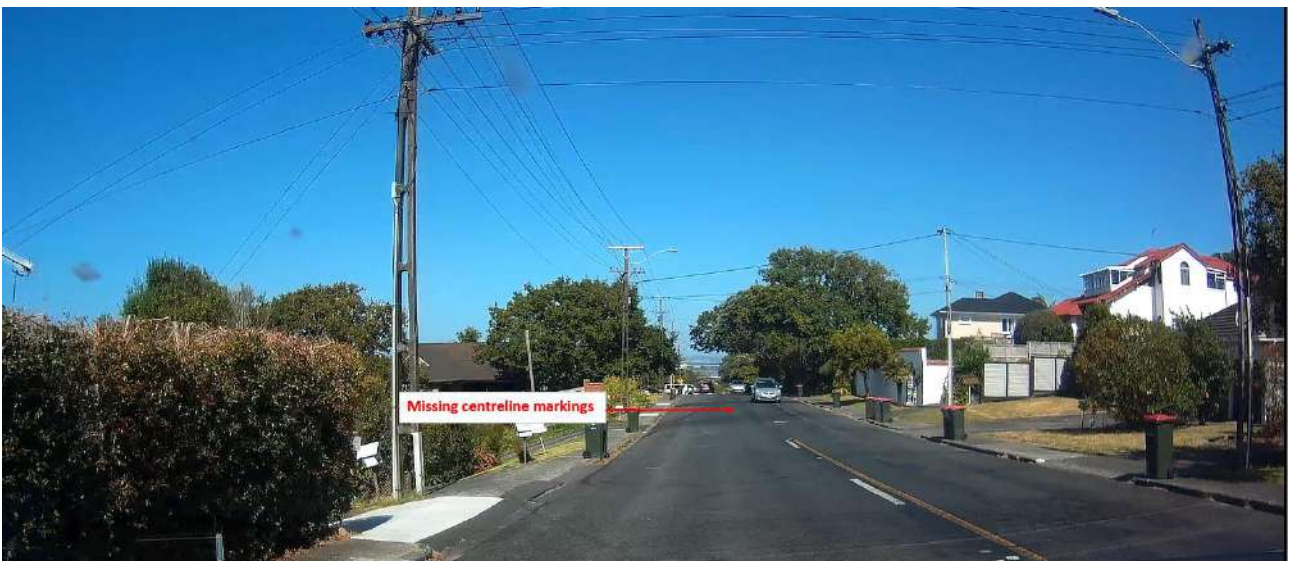
At present, the current centreline markings along Carlton Street varies between double yellow no-overtaking lines, single yellow no-overtaking lines, single centre lines and no centreline markings. A centreline is used to define the portion of a two-way sealed roadway available for travelling in each direction. It also provides a simple and continuous form of delineation along the corridor. Therefore, providing a consistent and appropriate centreline along the corridor where there are currently no centrelines could enhance the safety of this corridor with better lane management. It was also observed on site that some of the existing centreline markings were faded and in poor condition.

Figure 10: Missing centreline marking along the corridor

- Auckland Transport to review the centreline marking along the corridor and provide appropriate centreline markings where there are currently no centreline markings provided.
- Review the condition of the existing centreline marking and remark to appropriate standards.
- Remove any redundant RRPMs within the centreline markings.

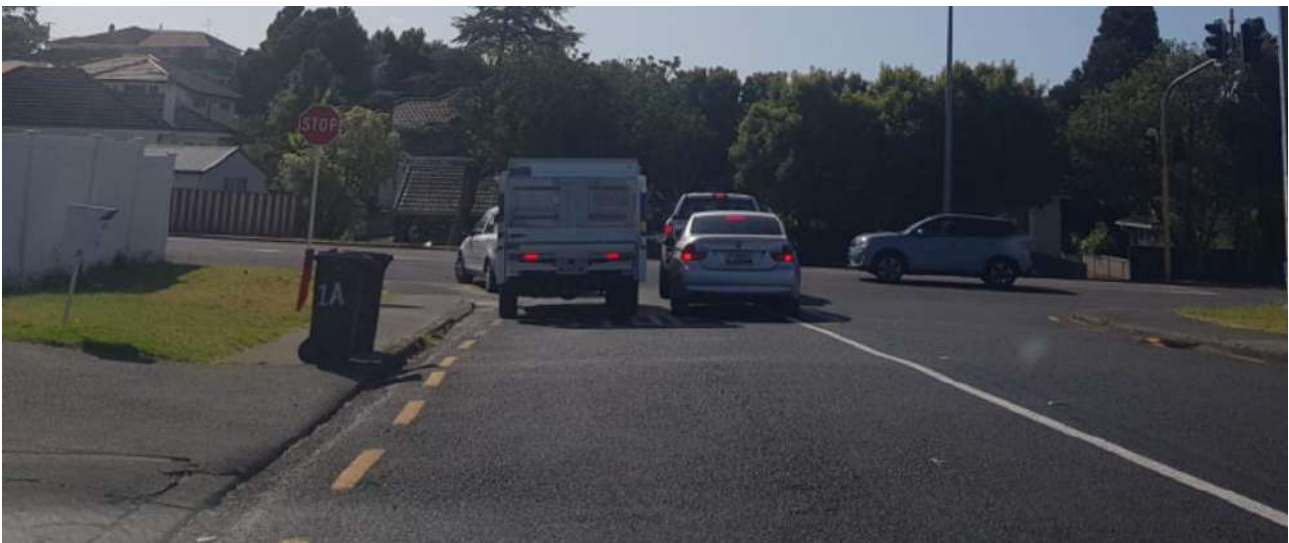
The right-out movement took longer to find a gap and safely merge into Hillsborough Road. As the queues were building up, the left-turn out traffic were trying to squeeze around the vehicle that was waiting to turn right out. Hence, this exit lane on Carlton Street was still operating as two lanes instead of one in some instances. With the narrowing of the exit lane, some right turning vehicles were following the new centreline and some were following the old redundant centreline. In a scenario where a right-turn out vehicle was positioned at the old centreline, and a bus were to turn right into Carlton Street, there could be a minor chance of a conflict between the two vehicles. However, this would only occur if a vehicle was positioned at the incorrect centreline. SAT could not ascertain if this behaviour was due to the fact that the redundant centreline marking was still visible or due to the fact that vehicles were trying to stay as far right as possible to allow for the two-lane operation. Should a crash occur, the likelihood of a serious injury would be very unlikely as the bus turning speeds would be very low.

Figure 11: Vehicles exiting Carlton Street still operate as two lane and the right turn vehicle cross the new centreline.

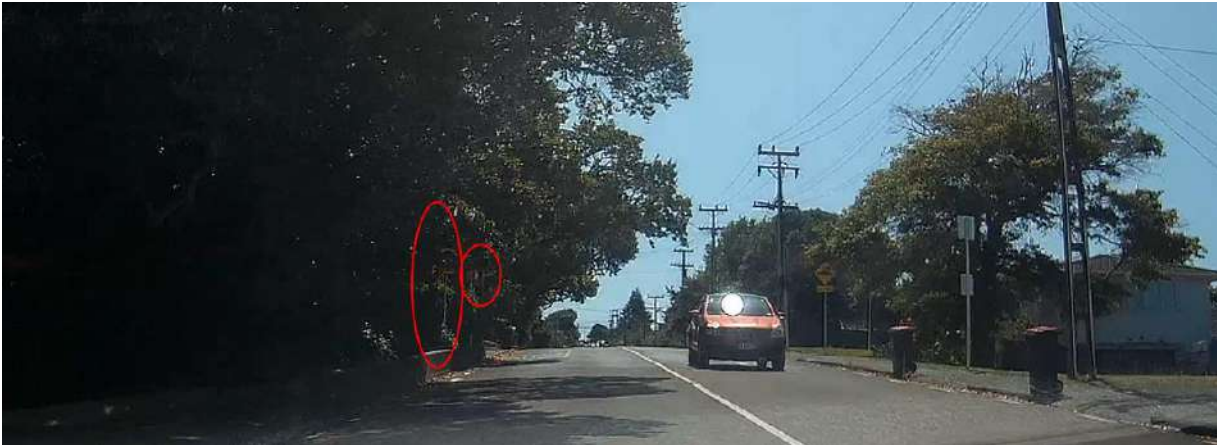
A number of signs were blocked by overgrown vegetation along Carlton Street. This was predominantly noted on the westbound direction near the first bus stop and at the start of the first speed table. These signs are important for unfamiliar drivers on the corridor as these are the first signs to indicate the presence of speed tables along the corridor.

Figure 12: Advanced warning of the speed tables ahead and bus stop signs blocked by vegetation

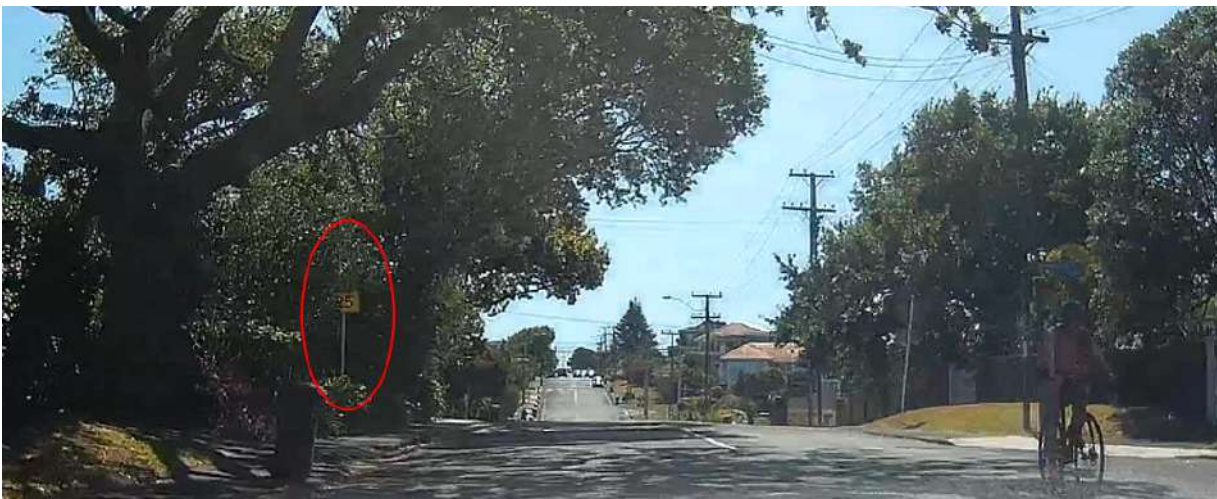
Figure 13: Speed table sign blocked by vegetation

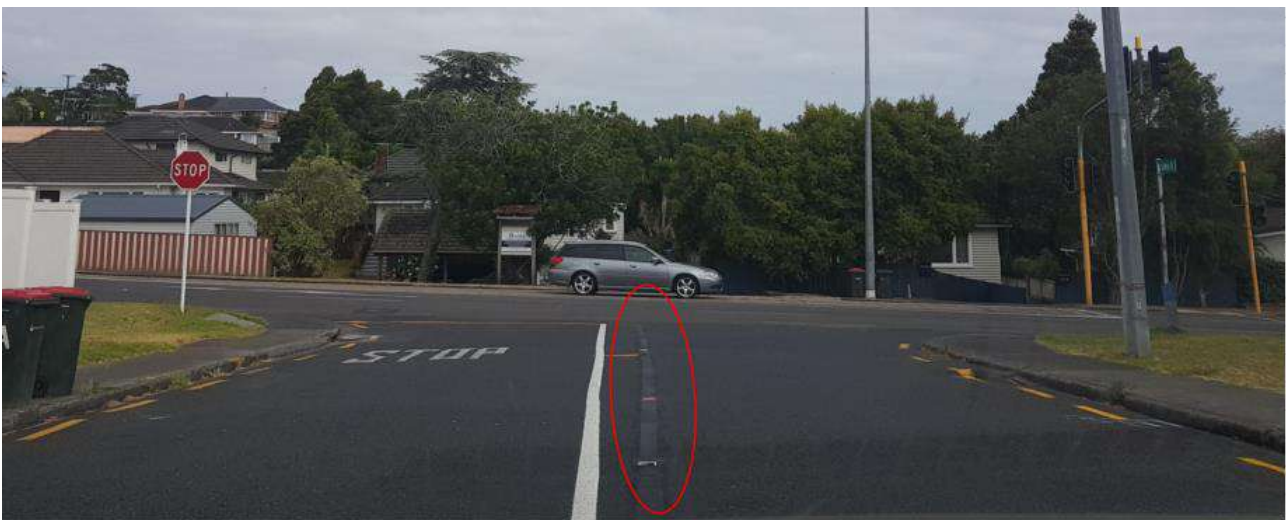
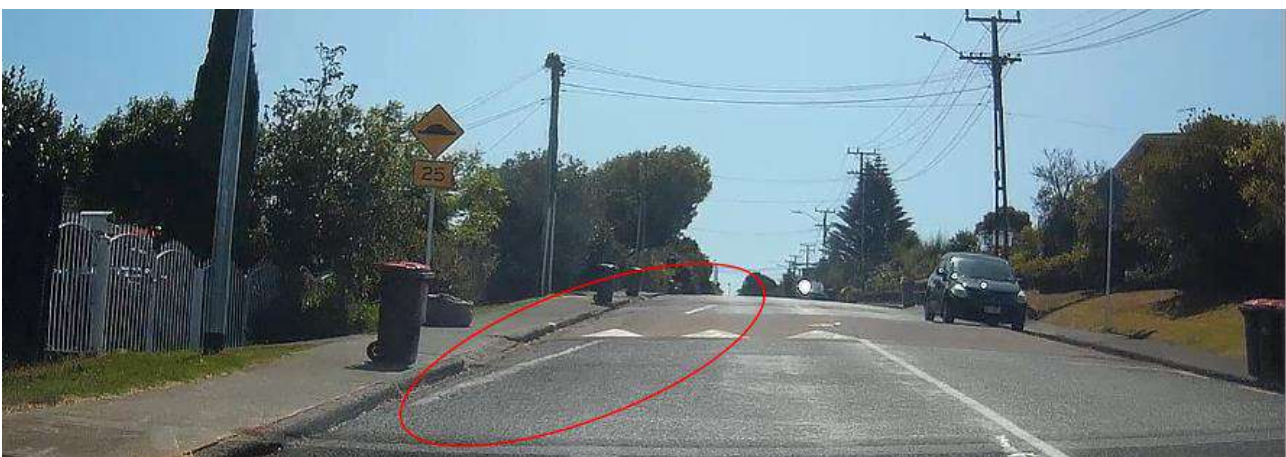
As part of the Carlton Street Improvement Project, some pavement markings such as the taper markings for previous side island delineations, raised reflectorised pavement markers (RRPM) and previous centreline markings at Carlton Street near the Hillsborough intersection were removed. It appeared that these were removed by blacking out the existing lines (ghosting out). However, some of these redundant markings were still visible and it is likely that during low light conditions or wet conditions, these ghost lines and redundant RRPMS may confuse some drivers. The SAT observed on site that some drivers were still following the old centreline location on Carlton Street at the Hillsborough intersection which may position drivers in a conflict location.

Figure 14: Redundant centreline, RRPMS still visible on site and redundant table still visible on site.

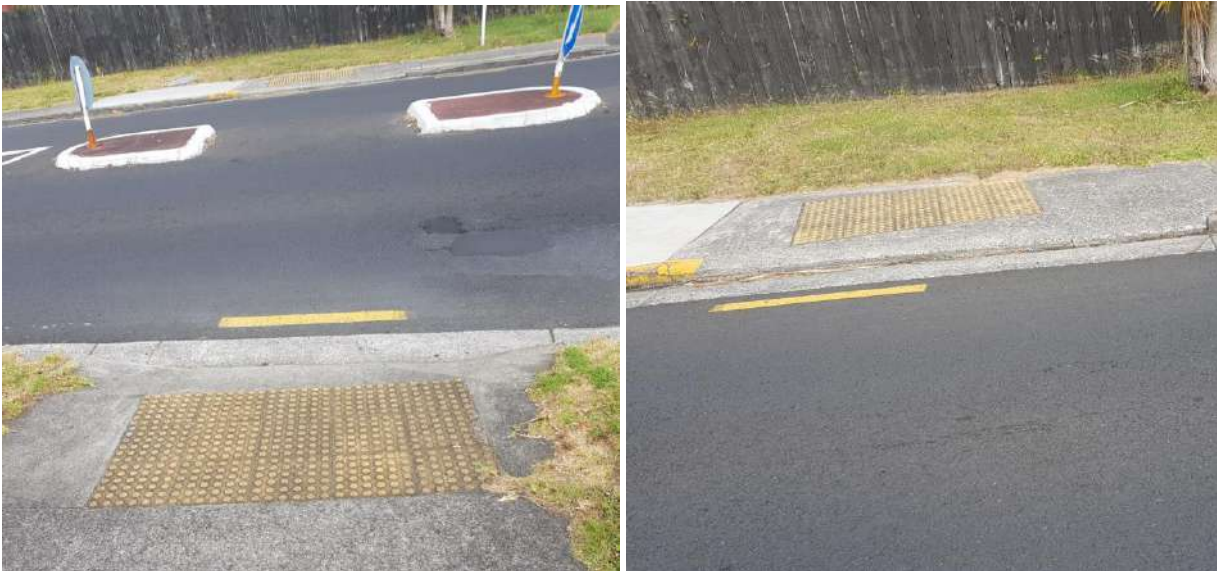
A pedestrian refuge island is located approximately 60m west of the Queenstown Road/Hendry Avenue/SH20 Queenstown Road Northbound Off Ramp roundabout. This crossing location is signed as the safe crossing point for cyclists and pedestrians using the Southwestern Shared Path at this roundabout. It was noted on site that the kerb lip on the pram ramp crossings were higher and not flushed with the road surface. This higher kerb lip would cause a tripping hazard for the users, particularly for elderly users as a fall could cause minor injury. SAT also observed on site that a mobility scooter using this crossing was struggling go over this pram crossing due to high kerb lip. This kerb lip would also cause a hazard for cyclists as they would be travelling in an angle to turn onto the footpath which could create an imbalance.

Figure 15: Refuge Island and the higher kerb lip

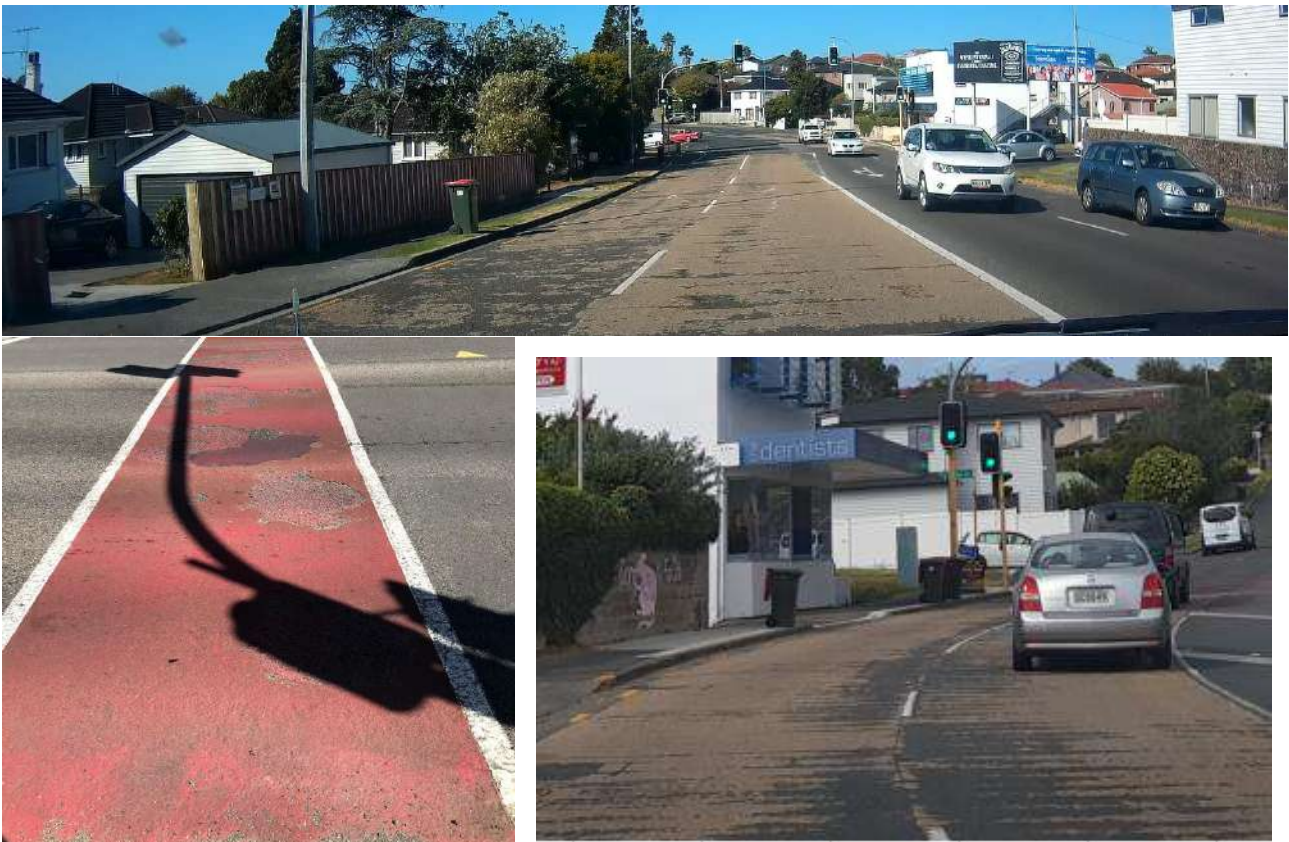
However, on site, the current condition of the high friction surfacing was observed to be poor and worn, the red colour surfacing on the mid-block crossing has faded/peeled off with uneven surfaces and the current pavement markings are in poor condition. The poor condition could mean the additional safety benefits anticipated from these enhanced surface treatments will be diminished. The expected crash types are predominantly rear end type crashes which are generally considered low severity in injuries.

Figure 16: Poor conditions of the current high friction surfacing and red colour surface treatments between the pedestrian cross walk lines.

- Auckland Transport to review the current condition of the high friction surfacing.
- Repair and renew the red colour surfacing between the pedestrian cross walk lines
- Re- mark all the pavement markings at this intersection

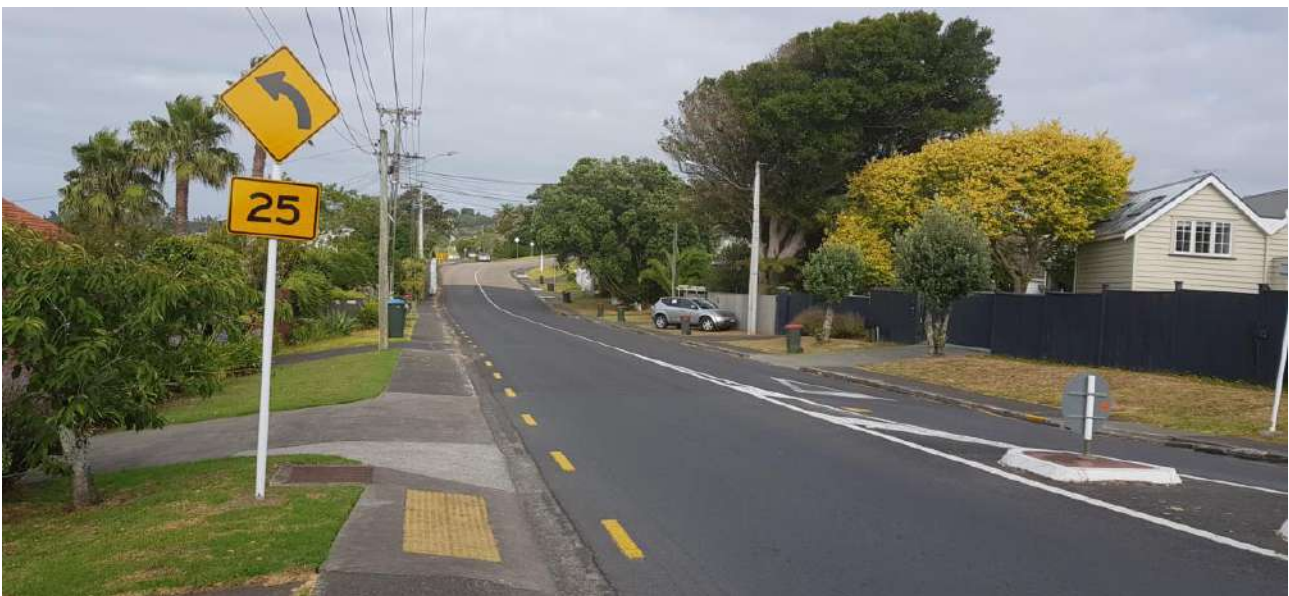
There were also no advanced curve warning signs or curve indicator signs installed for the eastbound direction of Carlton Street approaching the curve.

Figure 17: Incorrect advanced curve warning sign

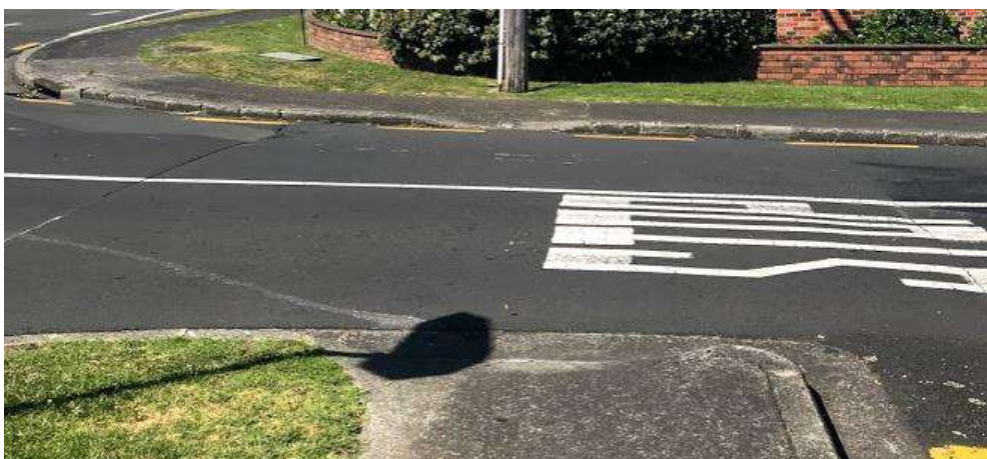
These inadequate facilities and conditions noted above increase the likelihood of pedestrians related crashes at this intersection. However, the approach speeds at this intersection are estimated to be low approximately 30km/h due to side friction (narrowing of lane) created by on street parking and drivers slowing down stop at the intersection. Therefore, should a crash occur at this intersection, the severity would be low given the low approach speeds.

Figure 18: Substandard pram ramps at Littlejohn Street Intersection

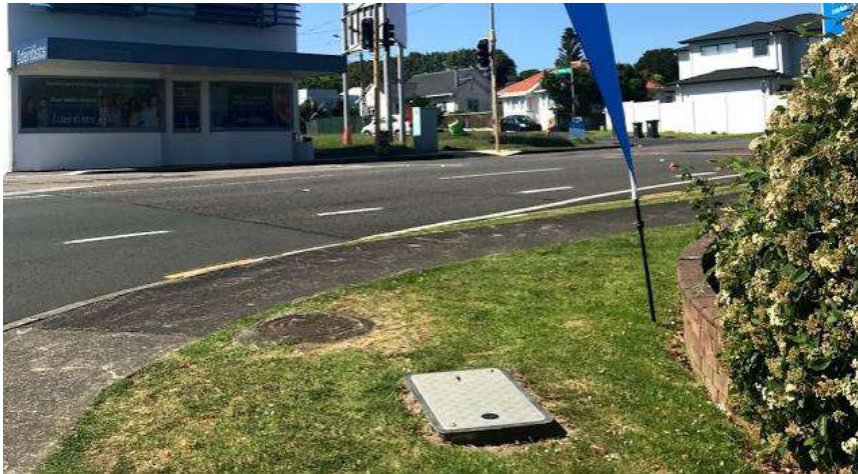
Figure 19: Limited sight distance for pedestrians crossing Littlejohn Street

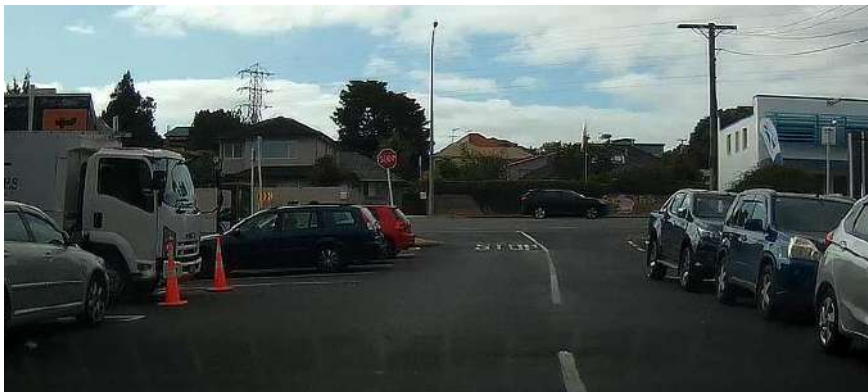
Figure 20: View towards the Hillsborough Road Intersection from Littlejohn Street

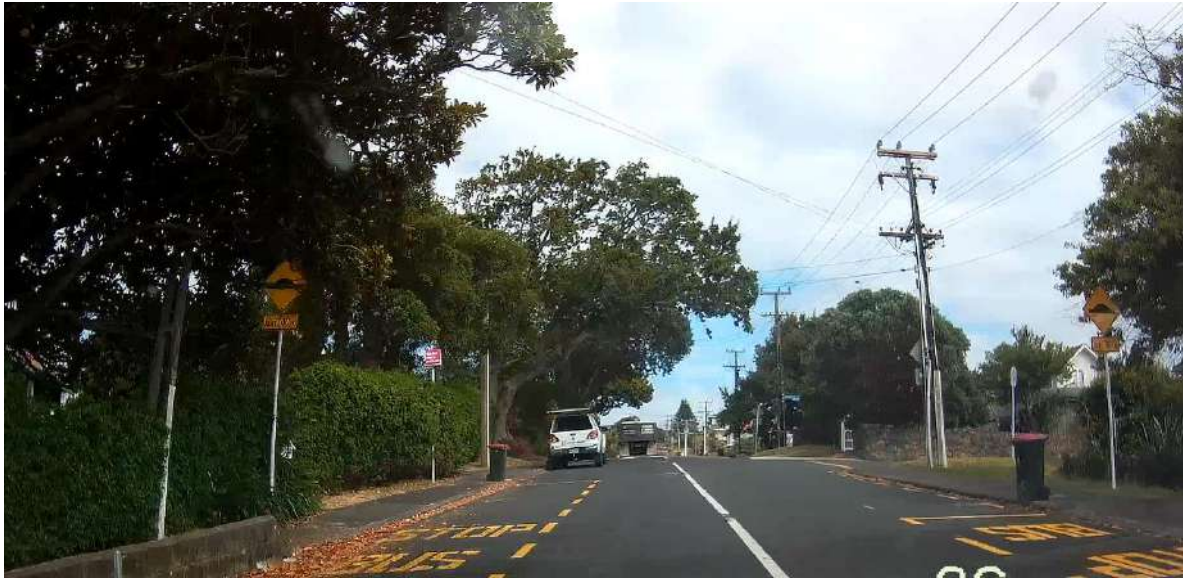
For the bus stops located (two stops with one on each side) at the eastern end of Carlton Street near the School/park, the approach speeds in both directions are estimated to be 30km/h due to the speed tables. On site, 'no-overtaking yellow' lines are installed between the bus stops, restricting drivers overtaking a stationary bus. Therefore, the likelihood of a head on crash occurring is low. The lower operating speeds also enables drivers to react to an oncoming vehicle to avoid a collision and reduce the severity of a crash.

Figure 21: View behind the bus stop for the westbound direction – eastern end of Carlton Street

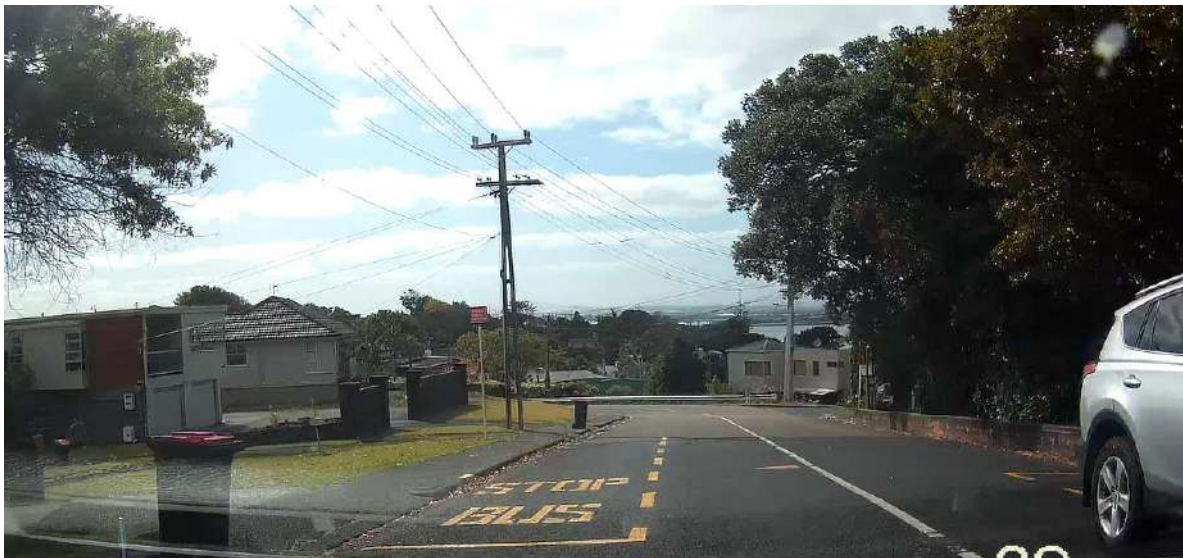
Figure 22: View behind the bus stop for the eastbound direction - eastern end of Carlton Street

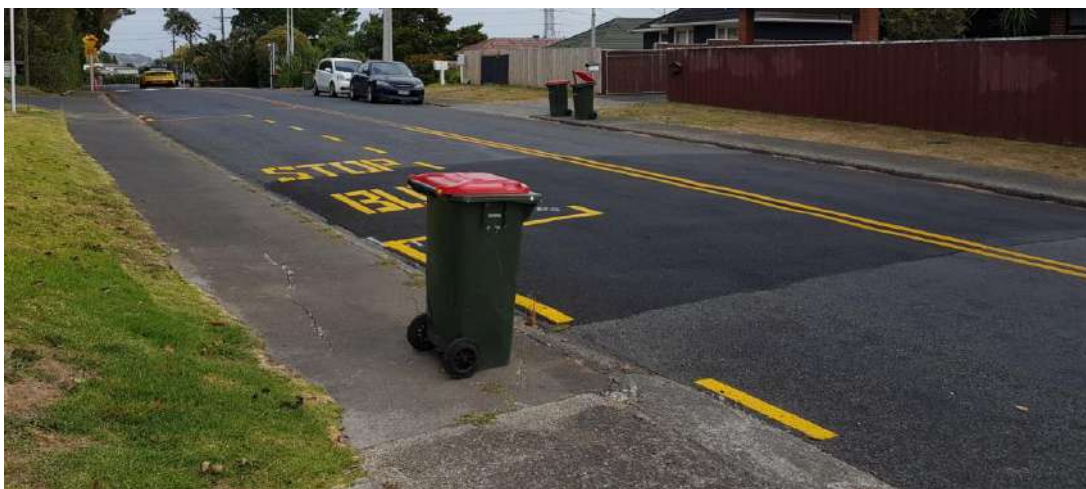
The proposed bus stops are located in close proximity to property accesses. When a bus is stopped at the bus stop, the sight lines for drivers exiting these accesses may be temporarily obstructed. Drivers may still choose to turn even with reduced sight lines when exiting the access resulting in a collision with oncoming traffic. However, these accesses are predominantly residential with low traffic volumes, and the bus frequency limited to four buses per hour per direction and the bus is only parked for a few seconds, therefore the probability of a crash occurring is considered to be unlikely. However, should a crash occur, the likelihood of a fatal or serious injury crash is unlikely due lower operating speeds along the corridor.

Figure 23: View to the left from the property access near the bus stop on the westbound direction near school

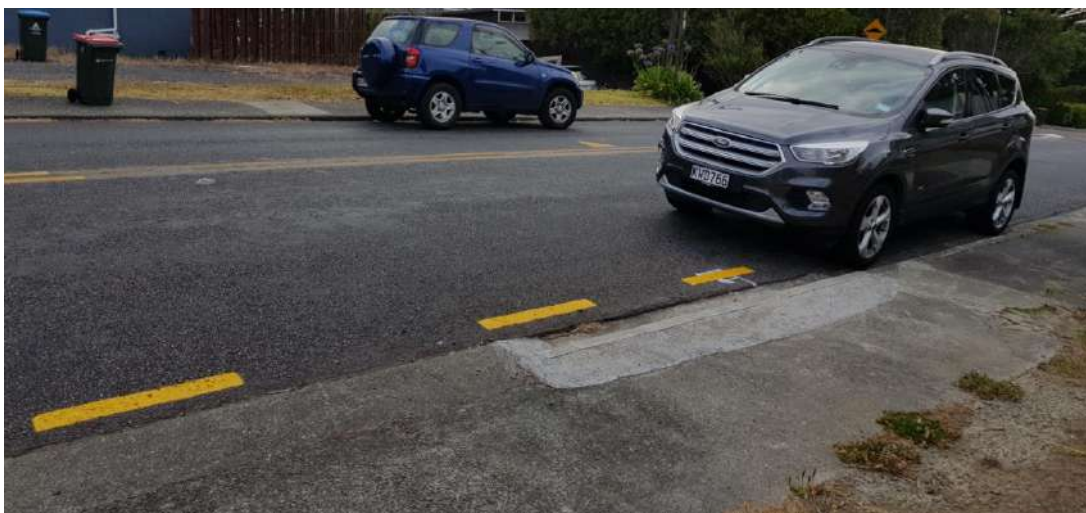
Some of these locations already have existing on street parking near the accesses, where parked vehicles could obstruct sight lines for longer durations. As parking is prohibited at the bus stops, the visibility from these accesses could be improved for most of the time.

Figure 24: View to the right from the access near the bus stop on the westbound direction near school indicating that parking already limits the sight distance to the right.

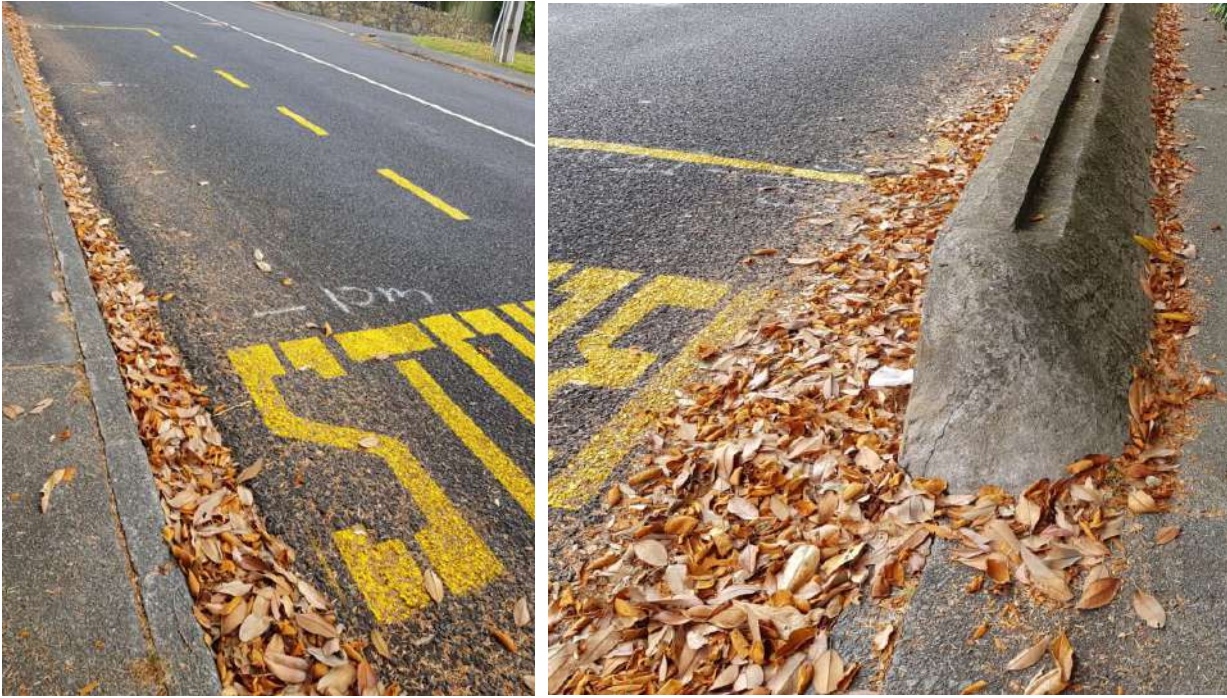
The westbound direction bus stop at the corner of Carlton Street/ Frederick Street Intersection is more prone to having vegetation and dead leaves accumulated due to a large tree. It is likely that channel will be blocked by the accumulation of this debris and could result in ponding on that corner and may affect the bus stop users. Therefore, it is recommended that regular maintenance and clearance be undertaken at this location to avoid any ponding related issues.

Figure 25: Accumulated debris near the bus stop blocking the channel.
