**Safety Review of Carlton Street Bus Route**

# Appendix A – Road Safety Audit Report

## Carlton Street Bus Route

Prepared for Auckland Transport  
by Beca Limited

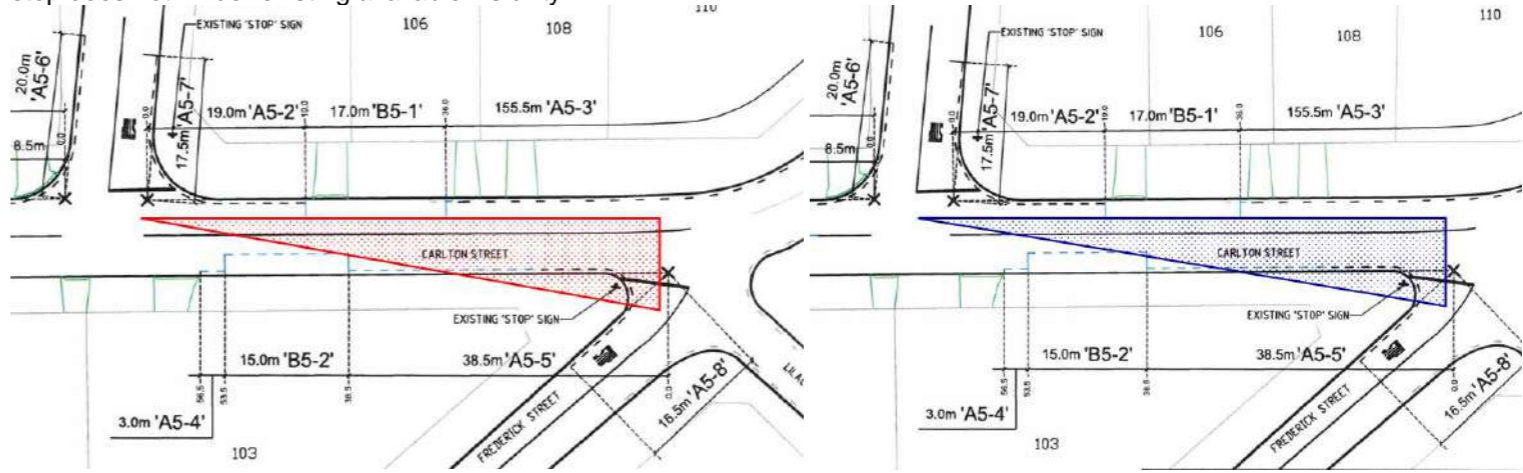
Issue & identified Safety Risk:	Questions:	Response
	<p>Q.10 What is the impact on safety of a bus stopped at westbound bus stop with reduced visibility for vehicles turning right and left out of Frederick Street onto Carlton Street?</p>	<p>The principles set out in the Austroads guide for 'Safe Intersection Sight Distance'<sup>1</sup> (SISD) were used to estimate the required sight distance. SISD reflects the intervisibility distance between drivers on Carlton Street and driver waiting on Frederick Street for an opportunity to enter Carlton Street. The SISD required towards Carlton Street for traffic exiting Frederick Street was calculated to be 65m and onsite this was observed to be approximately 60m. This indicates that currently there is insufficient sight distance towards Carlton Street for vehicles exiting Frederick Street.</p> <p>As seen below the red hatching shows the achieved visibility and the blue hatching shows the required visibility. The westbound bus stop does not hinder existing available visibility.</p>
